## Appendix B Stream Evaluation Guidelines:

Goal: Evaluate Appendix B waterbodies to determine whether they meet the current definition of WOTUS and whether listed designated uses are accurate.

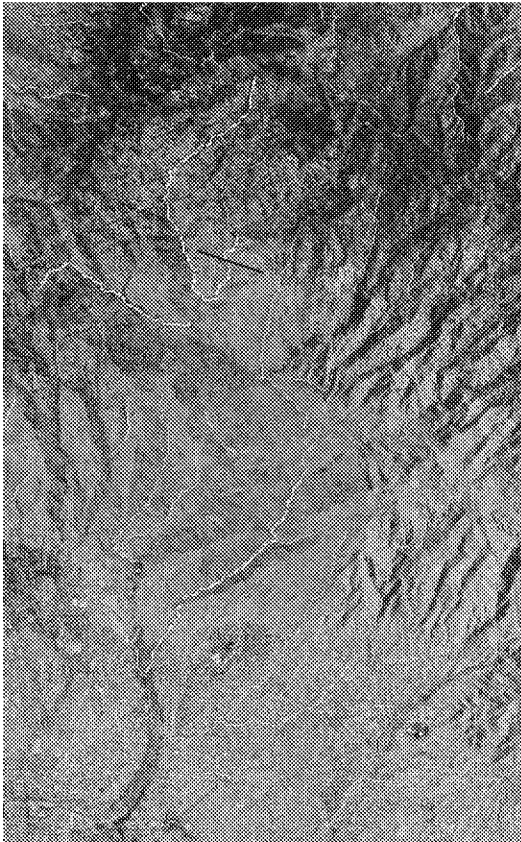
Figure [ SEQ Figure \\* ARABIC ]. Sabino Cr. (red dot is WWTP outfall, green dot is Dam, dark blue line is perennial segment)

In the example below, Sabino Creek has two reaches in Appendix B. Sabino Cr has perennial and intermittent segments in both reaches. In this case, the spreadsheet would be marked as “Y-RPW, perennial segments in reach” in the Eval\_reason field for both reaches, “Yes” for AZPDES outfall in the upstream reach, “No” for OAW on both, and comments listed and checked for records in GIS that don’t match.

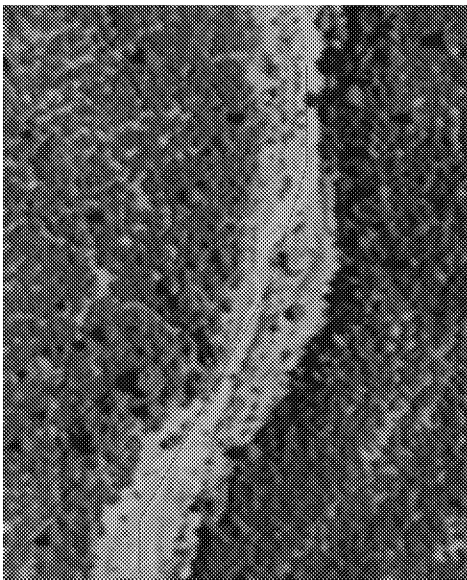
Figure [ SEQ Figure \\* ARABIC ]. Example ephemeral channel with B,B,OHWM - Copper Basin Wash. Note Lighter colored Bed that is free of vegetation, Banks denoted by small lines of vegetation, and OHWM change in vegetation density indicator.
